# South Burlington Stormwater Utility

## Cracked Sewer Force Main

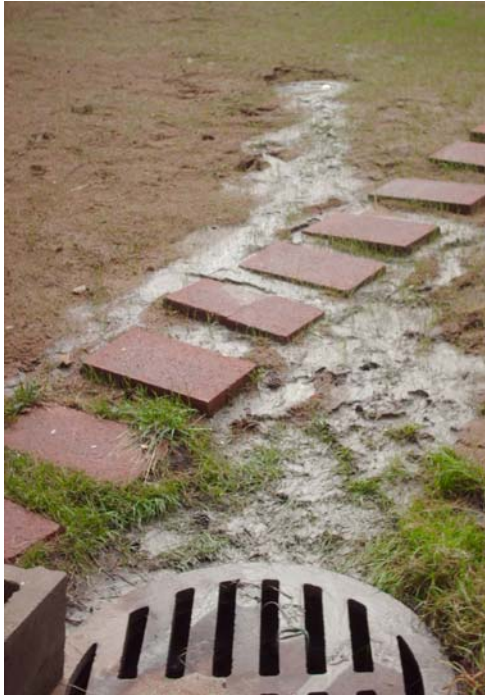
*Wastewater bubbling to the surface and flowing into a storm drain*

<p><b>Problem:</b></p>	<p>A homeowner observed water bubbling out of the ground near his house and reported the problem to the department of public works. The water had a strong odor and testing showed high bacteria levels (E. Coli). After it bubbled out of the ground, the water would flow into a nearby storm drain before discharging to a tributary of the Winooski River. City staff investigated the problem and determined that a nearby sanitary sewer pipe had cracked. The force main was several feet below ground, but pressure from the pump was causing the water to bubble to the ground surface. This posed both a public health risk and a threat to the environment.</p>
<p><b>Project Description:</b></p>	<p>City staff excavated down to the pipe. After careful examination, it was determined that the line could be repaired in place. Once the repair had taken place, the line was tested to ensure that there were no additional leaks or cracks. The area was then back filled, seeded, and mulched.</p>

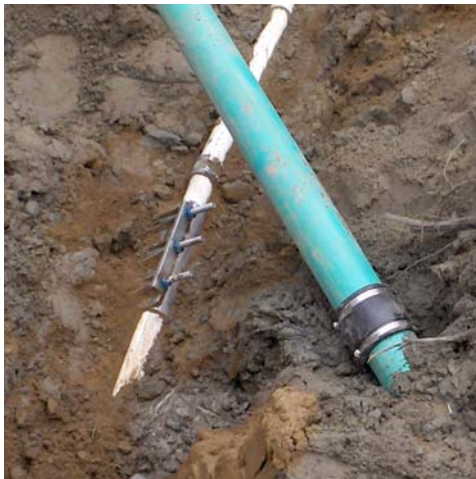
*Repaired 2" sewer line underneath stormwater piping*
