# South Burlington Stormwater Utility

## Airport Parkway Drainage Repair

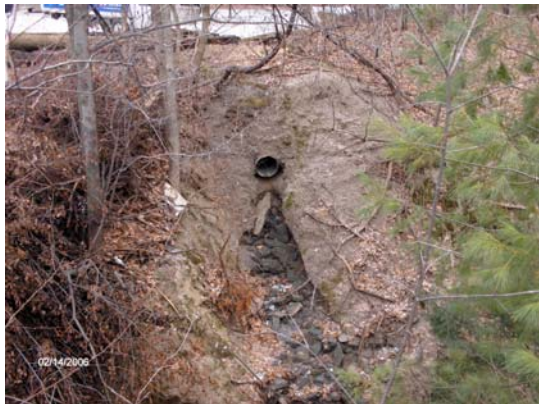
*Discharge pipe before the project*

<b>Location:</b>	Airport Parkway
<b>Problem:</b>	Two stormwater discharge pipes from Airport Parkway and a nearby parking lot had caused severe erosion to the highway bank. The erosion and resulting instability threatened to cause the highway to fail; resulting in major and expensive road repairs.
<b>Benefit:</b>	The repair of this discharge area ensured the stability of Airport Parkway and reduced the environmental impact of the stormwater runoff. In addition to stabilizing the highway, the project greatly reduced the flow of sediment to a nearby pond, which ultimately leads to the Winooski River.
<b>Description:</b>	To prevent further erosion, a new discharge structure was constructed further down the bank, combining the two discharge pipes, and the discharge area was lined with stone. The damage was then reversed by filling in the eroded area and stabilizing it with grass and erosion control matting.

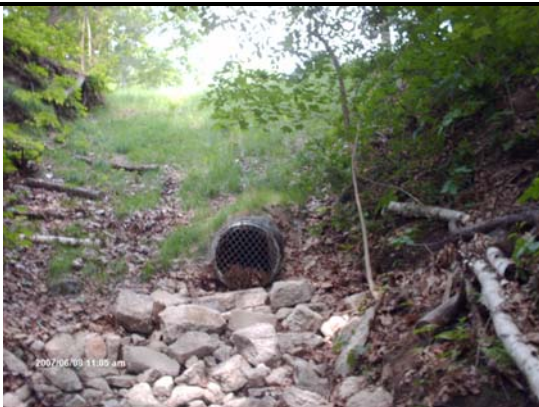
*New stormwater outflow*

<b>Dates/Timeline:</b>	2006
<b>Total Project Value:</b>	\$20,000
<b>Funding Sources:</b>	Stormwater Utility Fund Vermont Better Back Roads Grant Program
<b>Best Management Practices:</b>	Installed Stone-Lined Swale Repaired Stormwater Infrastructure
