South Burlington Stormwater Utility

Sanitary Sewer Pipe Connected to Stormwater Pipe

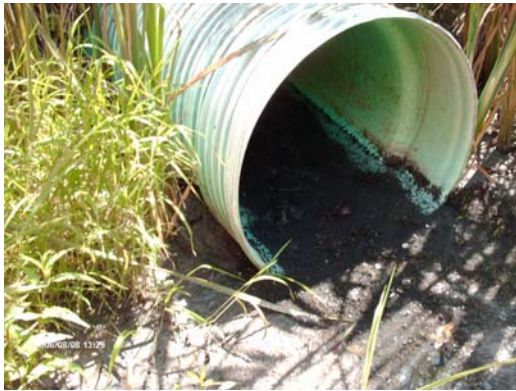
Outfall pipe where sanitary connection was discharging

<p>Problem:</p>	<p>During routine road repair, City staff detected a septic odor emanating from a stormdrain. Further investigation uncovered that a sanitary sewer pipe had been accidentally connected to the stormwater drainage pipes. Unlike sanitary wastewater, which goes to the wastewater treatment plant and is treated prior to discharge, stormwater pipes drain directly to the waterways (i.e. streams, wetlands, and the lake). This discharge had been occurring from 1994 until it was fixed in 2006!</p>
<p>Project Description:</p>	<p>Immediately upon discovery the homeowners were notified of the problem. The pipes were dug up and re-connected to the correct pipe system. Investigation of nearby outfall pipes was undertaken to ensure that no other illicit connections had been made in the area.</p>
<p>Benefit:</p>	<p>Proper connection of the pipes will ensure that the sanitary wastewater will be sent to the wastewater treatment plant prior to discharge to surface waters. Subsequent monitoring has shown reduced pollution at this outfall. In addition, plumbing problems previously reported by the homeowner were resolved during the work.</p>

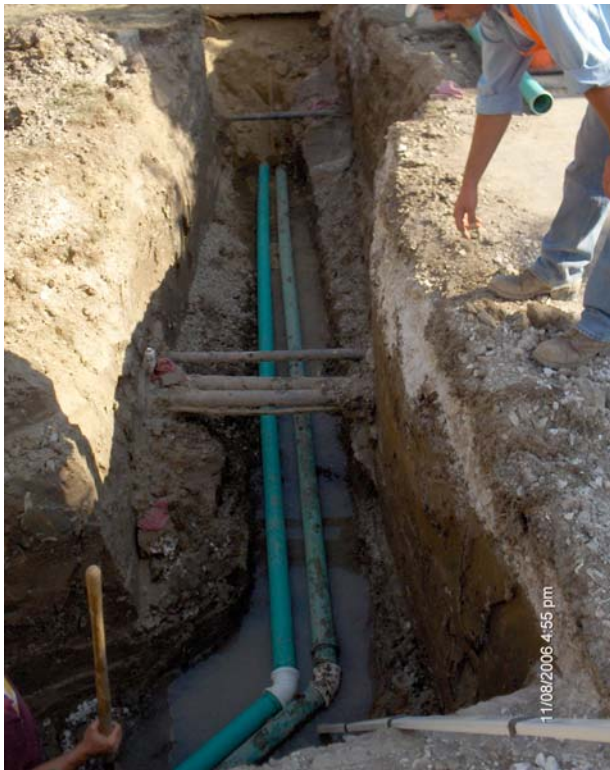
New sanitary pipe was connected to the sewer and existing foundation drain left in place
