South Burlington Stormwater Utility

Meat Department Floor Drain Discharge

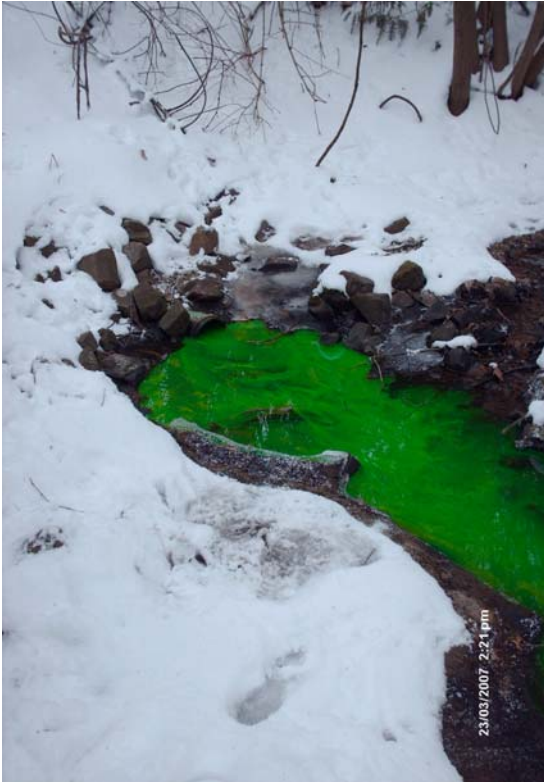
Green dye poured into meat department floor drain discharging into Potash Brook

Problem:	Stormwater Utility staff was conducting routine water quality sampling when it discovered a discharge pipe behind a supermarket was delivering elevated levels of E. Coli to Potash Brook.
Project Description:	Utility staff followed up with personnel at the supermarket and dye-tested floor drains throughout the store. It was determined that a floor drain in the meat department was discharging directly to Potash Brook. When deli staff cleaned counters and floors at the end of the day, the washwater would end up in the floor drain and be discharged directly to the stream. Contaminants from this discharge could include: soaps, debris, sediment, and cleaning detergents. The supermarket agreed to plug the floor drains and subsequent testing has shown reduced levels of E. Coli in the stream near this discharge pipe.
Benefit:	Reduced amounts of E. Coli, soap, and detergents discharged to Potash Brook

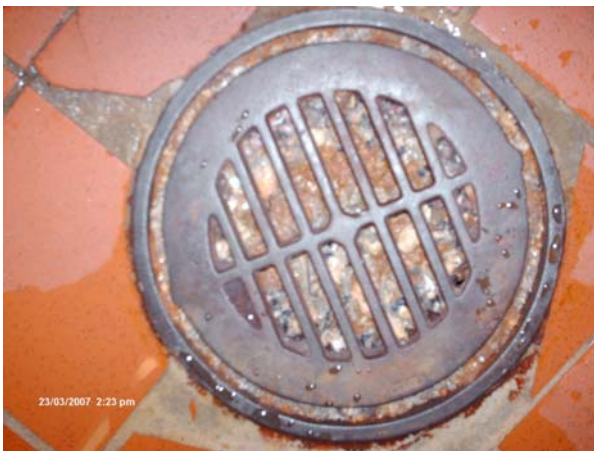
Meat department floor drain.
