South Burlington Stormwater Utility

Vehicle Washwater Discharge

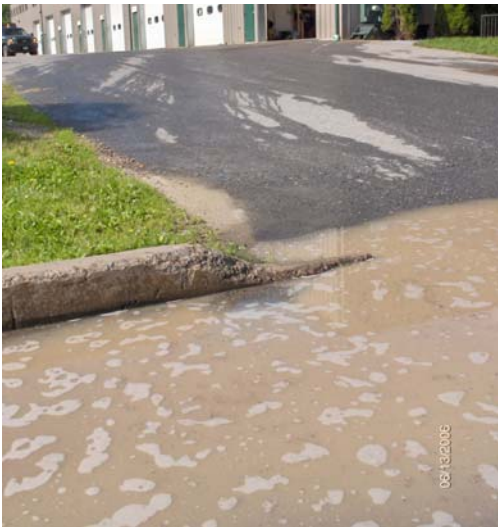
Example of polluted run-off from vehicle washing

<p>Problem:</p>	<p>Residents observed a soapy discharge in a small tributary of Potash Brook. Stormwater Utility staff investigated and traced the discharge back to a trucking facility. Fleet vehicles were being washed on a regular basis and the washwater was allowed to flow into a nearby storm drain. Vehicle washwater should not be discharged directly to surface water as it can contain high levels of sediment, oil, and phosphorus from the soap</p>
<p>Project Description:</p>	<p>City staff met with facility's manager and worked to eliminate the discharge. The storm drain that collected the vehicle washwater was directed to a new oil water separator and then sent to the wastewater treatment plant for further treatment. The vehicle washing area was also re-graded to minimize the amount of water that would flow to the wastewater treatment plant during a rain storm.</p>
<p>Benefit:</p>	<p>The trucking company can now wash their vehicles without discharging sediment and phosphorus to the stream.</p>

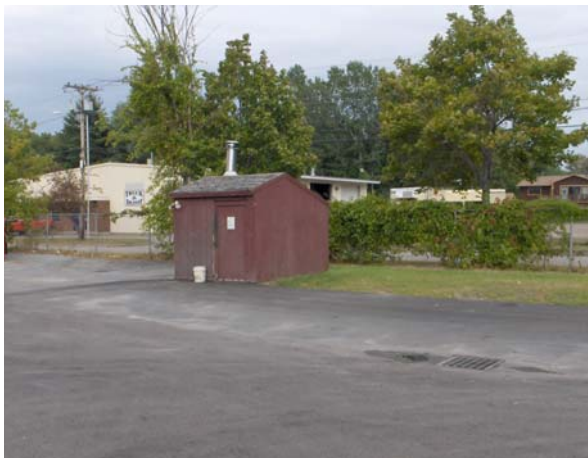
Reconstructed vehicle washing area
